Manhole Inspection Summary

Manhole # S09EE2019MH

Insp Date: **10/6/06 8:40 AM**

Location Address: **5914 GREENSPRING AVE**

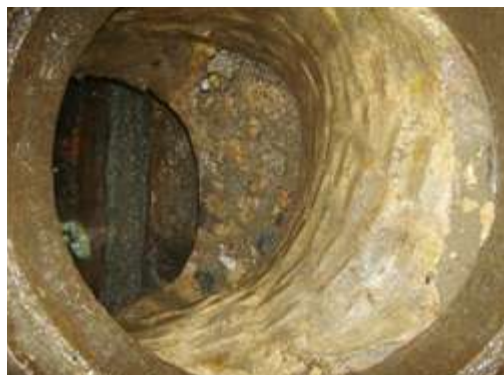
Top View

Frame leaks. Adjustment and Corbel infiltration. Bench debris.

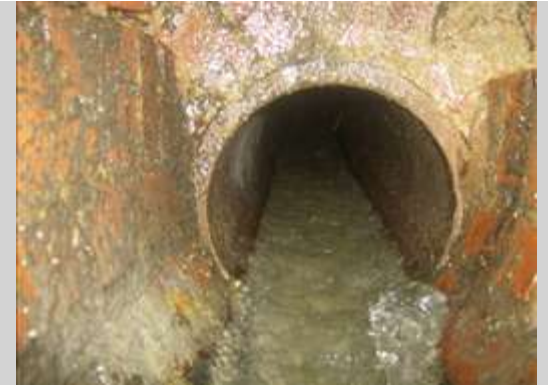
10 in. Circular Gravity Sewer Pipe Out @ 12 O'Clock

Pipe Material: **Clay** ☐ Pipe Lined

Invert Depth: **7.90** (ft.) Flow Characteristics: **Fast**

Infiltration: **None** Pipe Seal Cond: **Unknown**

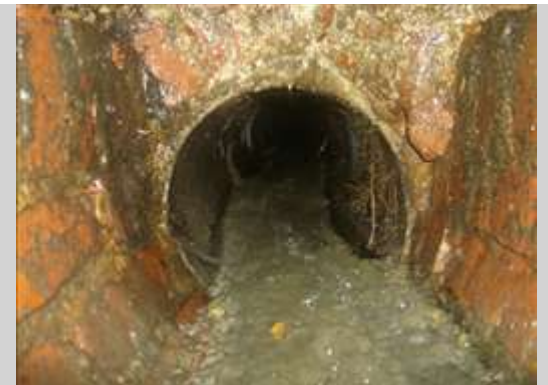
10 in. Circular Gravity Sewer Pipe In @ 6 O'Clock

Pipe Material: **Clay** ☐ Pipe Lined

Invert Depth: **7.50** (ft.) Flow Characteristics: **Fast**

Infiltration: **None** Pipe Seal Cond: **Roots**

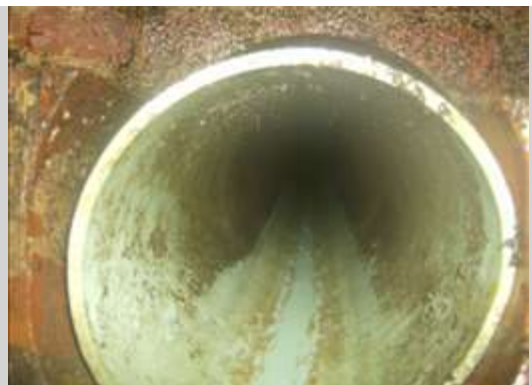
8 in. Circular Gravity Sewer

Pipe Material: **PVC**

Invert Depth: **7.30** (ft.) Flow Characteristics: **None**
